NASA Technical Memorandum 104059

# Structural Integrity of Wind Tunnel Wooden Fan Blades

Clarence P. Young, Jr., Robert T. Wingate, Kenneth W. Mort,  
James R. Rooker, and Harold E. Zager

April 1991

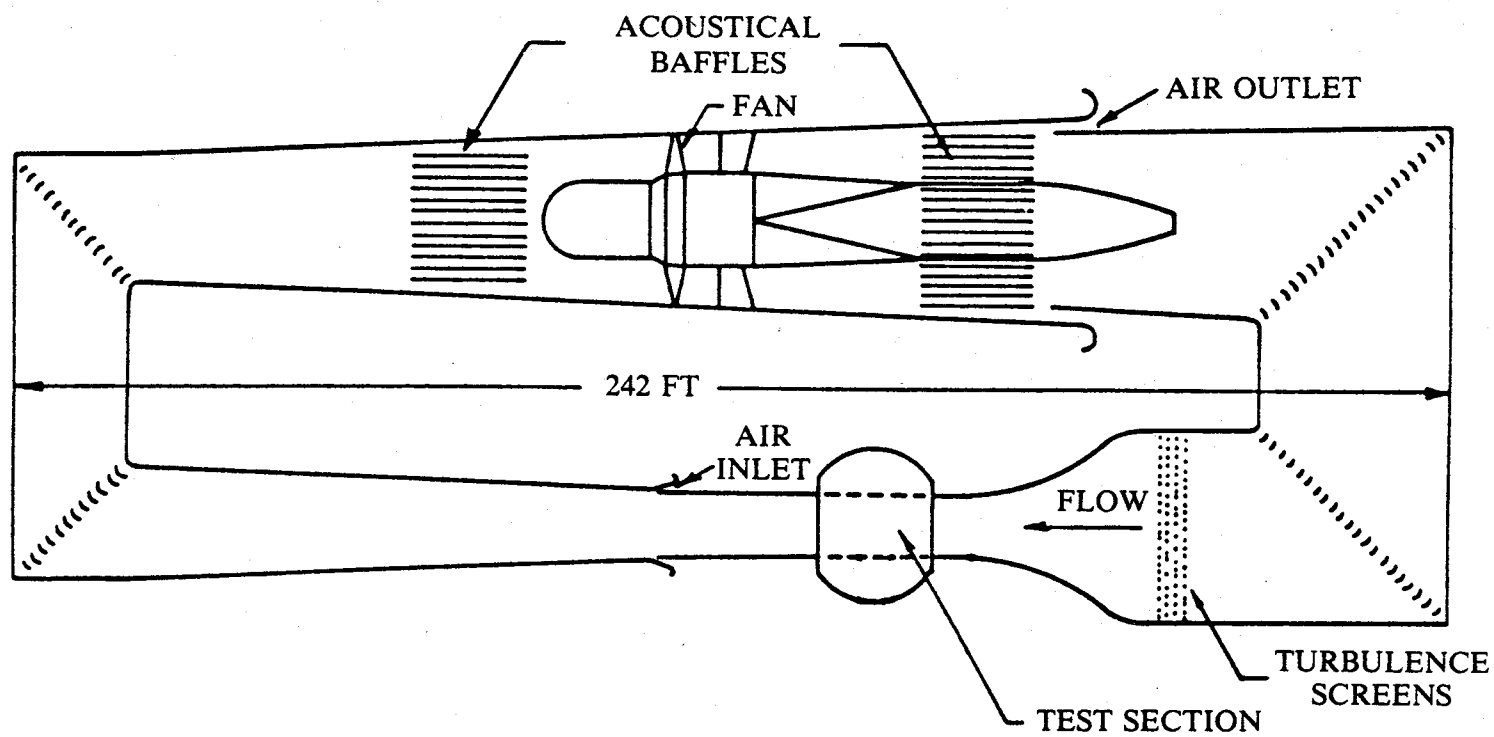
During operation at 0.8 Mach number on July 9, 1985, a catastrophic failure of all 18 Sitka spruce fan blades occurred. The failed blade set had been in use since 1975. In addition to blade loss, the main drive shaft was bent for a total estimated damage loss of \$1.7 million.

The findings of the investigation board (see references 5 and 6) attributed the failure to shear out at the root attachment caused by wood fatigue thereby leading to total destruction of the entire blade set. In addition, the flexibility of the drive shaft coupled with the small operating clearance between the blade tips and tunnel shell contributed to the rapid destruction of the blades and subsequent mechanical damage. Contributing factors were apparent inadequate design consideration of high stress concentrations at the blade attachment pin hole boundaries, fatigue, unsteady aerodynamic loading, and the thermal environment in the fan cavity. It was also found that the inspection techniques were inadequate, especially when assessing the criticality of detected flaws.

Figure 3. - NASA Langley Research Center  
High Speed 7- by 10-Foot High Speed Wind Tunnel

A number of actions have been taken to minimize the risk of future blade failure. The replacement blades have been redesigned in the root/hub region to lower operating stresses; inspection procedures have improved and include periodic removal of blades; permanent drive vibration sensors have been installed; temperature measurement and monitoring in the fan cavity is being implemented, the blade/shell clearance has been increased; a foam witness pad has been installed to indicate changes in tip clearance, and frangible blade tips have been installed.

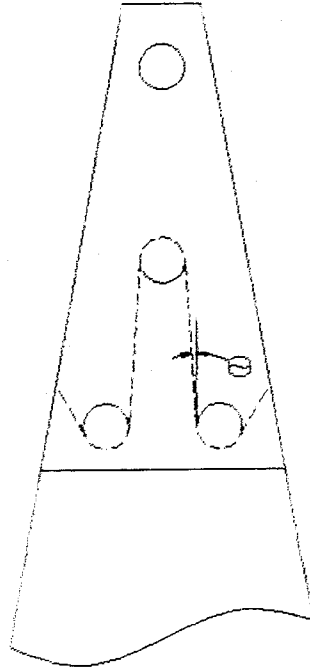
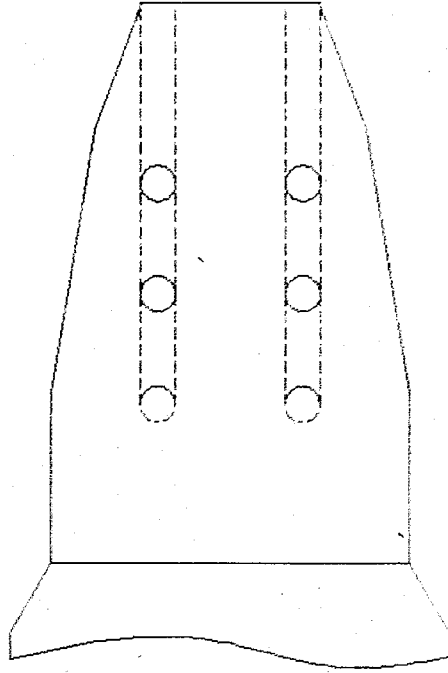
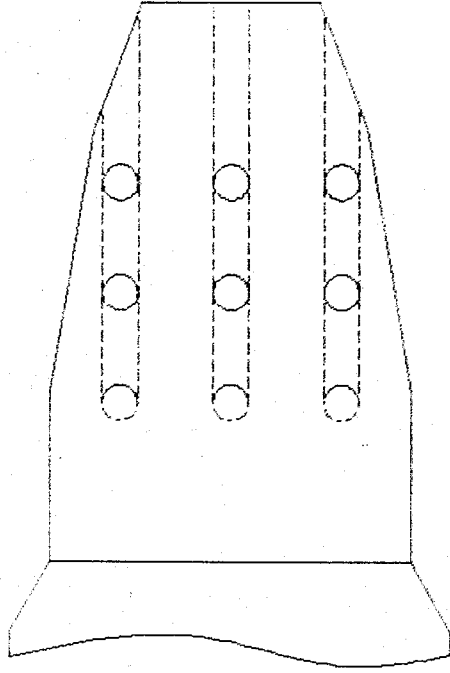
The attachment shearout addresses the bolt or pin hole pattern in the blade butt. A significant risk exists when a line drawn from the outside diameter (OD) at one hole to the OD of the hole below it makes an angle  $\theta$  less than 10° with the wood grain (see fig. 12). This type of attachment pattern is a high risk if the shearing along these lines could lead to the single mode shearout of a plug of wood as illustrated in figure 12. Also, edge distance (distance from loaded bolt hole(s) to free edge) can lead to stress risers with high potential for crack growth away from the hole and into the hole if the distances become too small. A distance of several diameters is highly desirable.

Figure 12. - Hub Attachment Geometries Illustrating Shear-Out Failure Modes  
for Different Bolt Hole Patterns

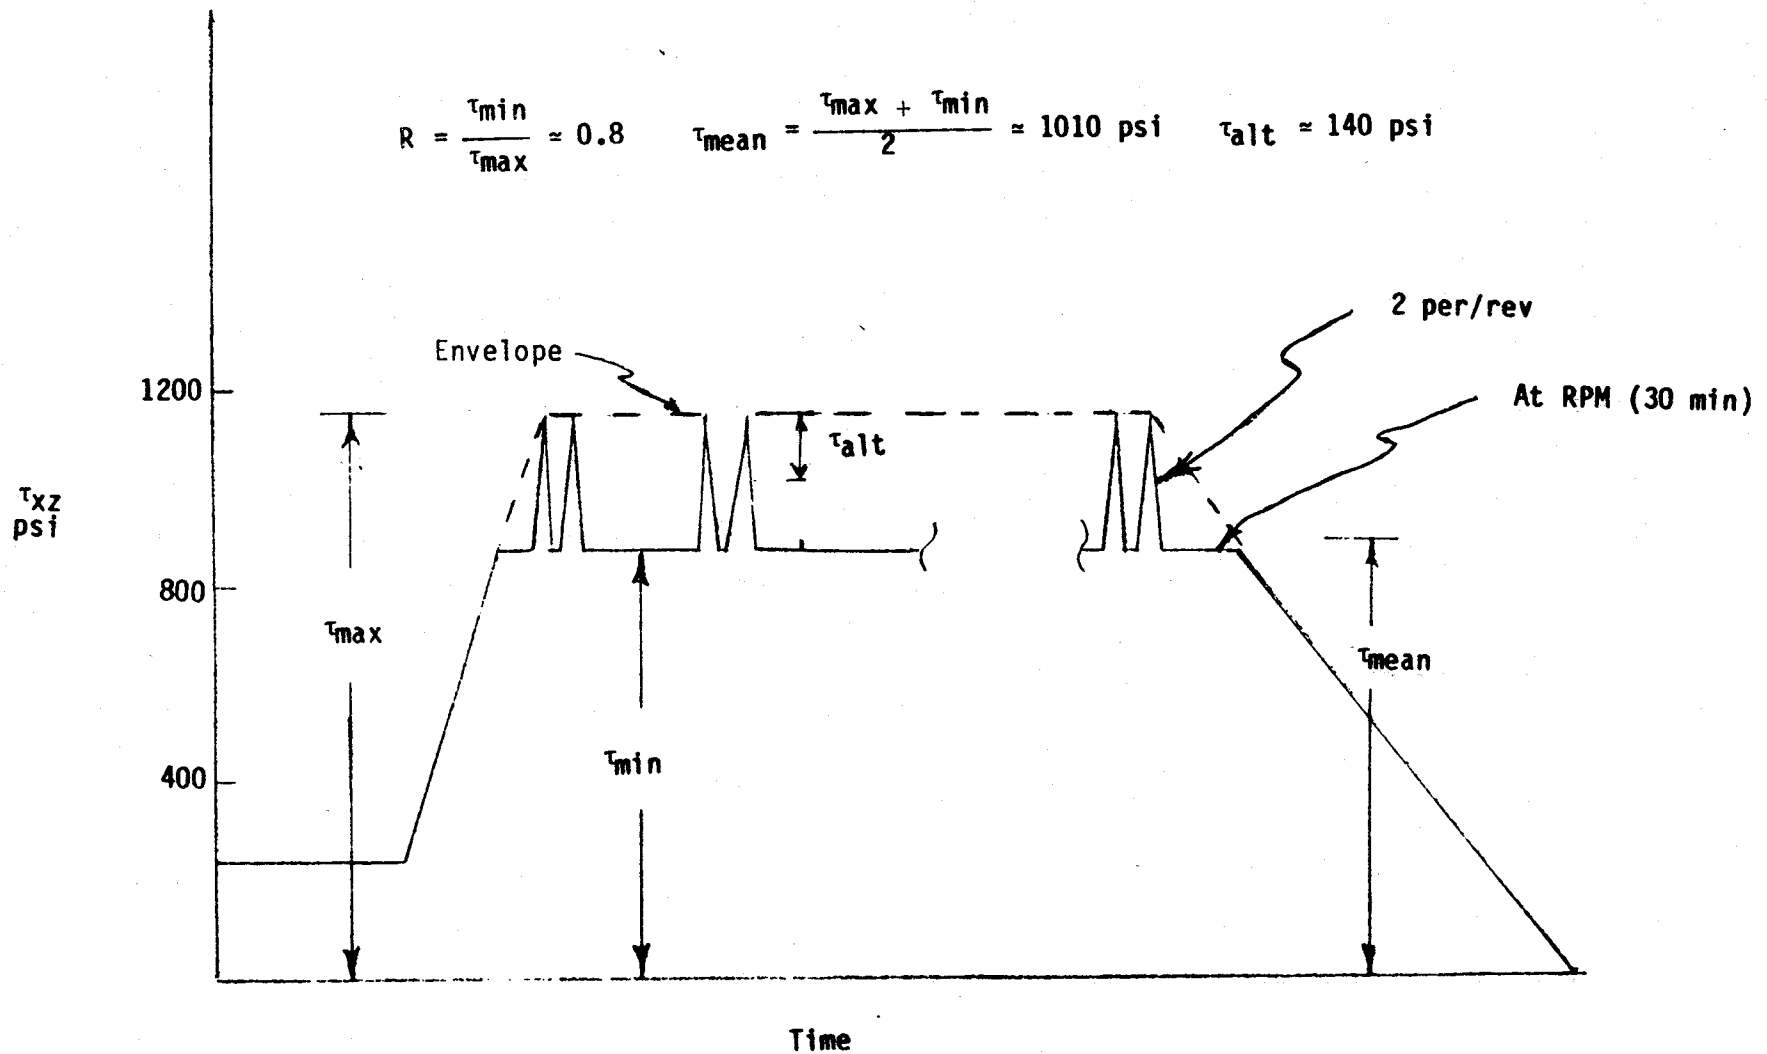
Work performed at LaRC to study the 7- by 10-Ft High Speed Wind Tunnel fan blade failure identified fatigue failure associated with high shear stress around the pin holes. Also, since the cyclic loading on fan blades may be complex and generally does not occur at stress ratios ( $S_{min}/S_{max}$ ) of zero, fatigue data should be adjusted for mean stress effects. Limited tests at LaRC suggest that the modified Goodman diagram can be used to approximate the effect of mean stress for wood. Although the Goodman approach is valid for metallic materials, it remains questionable whether it is valid for wood (composites). Further work is needed in this area. Based on the history of wooden fan blade failures and the complexity of stress distribution in

7 X 10 FAN BLADE  
CHARACTERIZATION OF CYCLIC LOADING

$$R = \frac{\tau_{\min}}{\tau_{\max}} \approx 0.8 \quad \tau_{\text{mean}} = \frac{\tau_{\max} + \tau_{\min}}{2} \approx 1010 \text{ psi} \quad \tau_{\text{alt}} \approx 140 \text{ psi}$$

Figure 18. - Cyclic Shear Stress in Region of Highest Loaded Fan Blade Attachment Hole for the NASA Langley Research Center 7- by 10-Foot High Speed Wind Tunnel during Operation at 475 RPM.

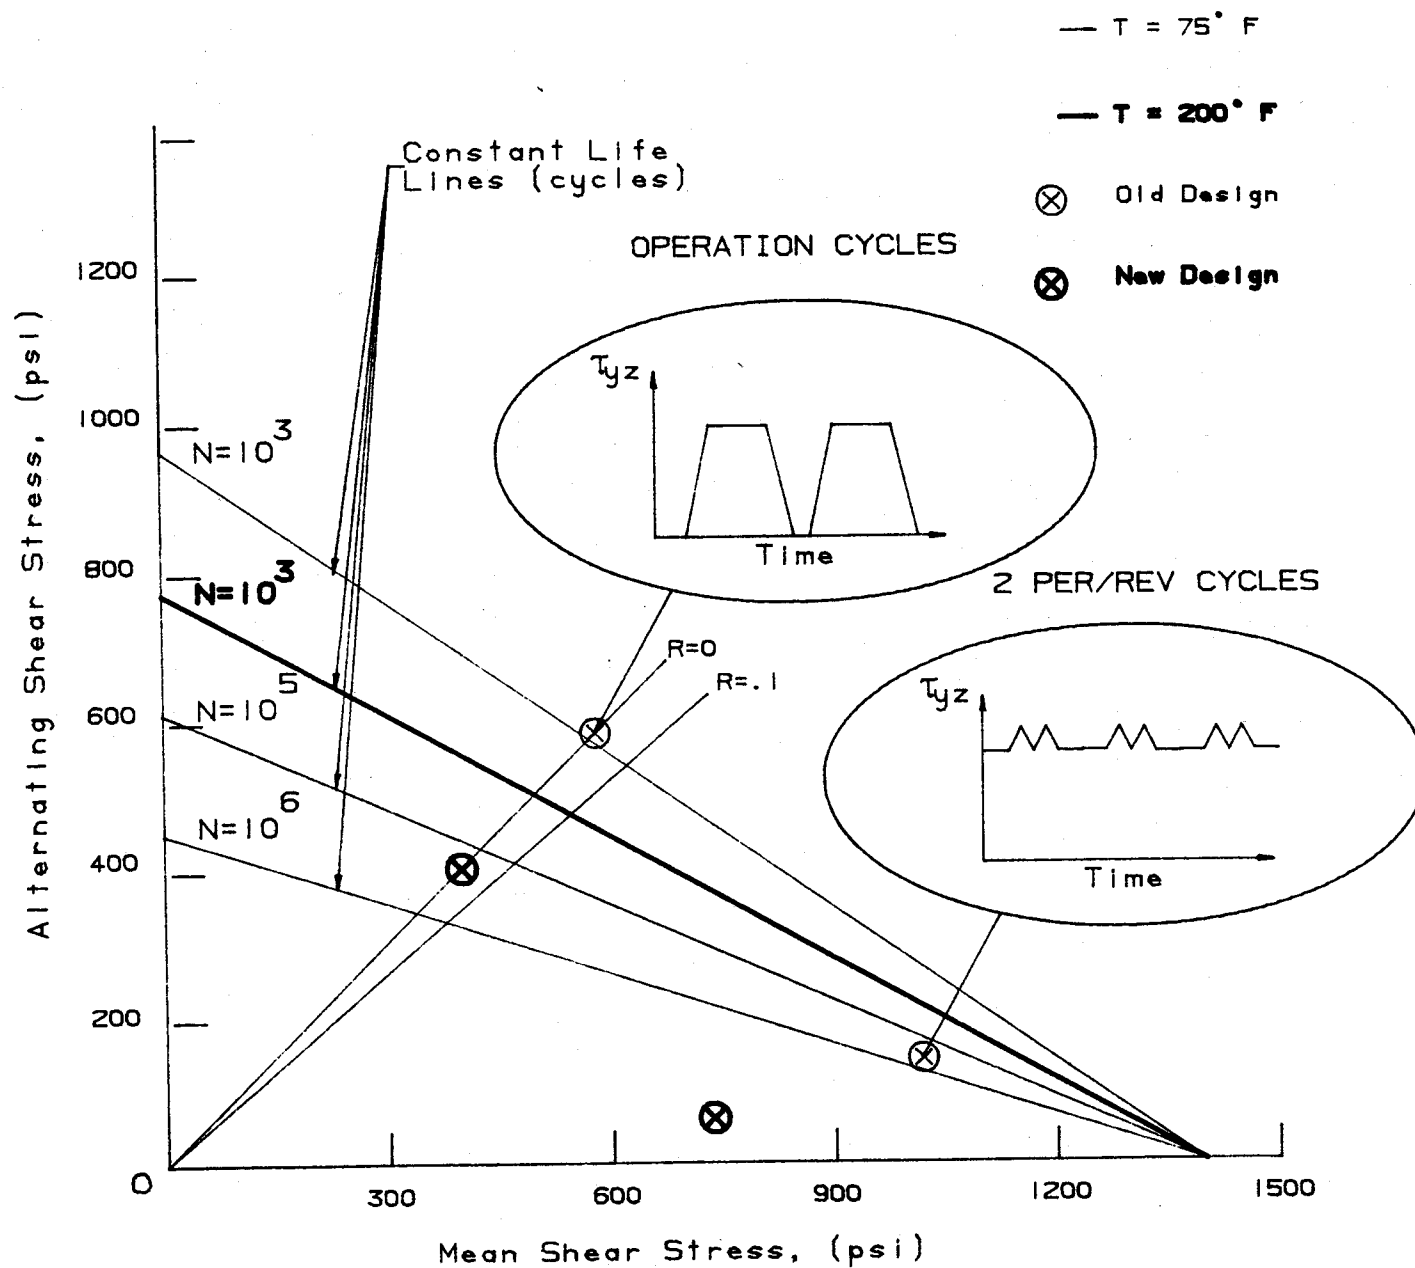
Since most S-N curves will be developed for a single R value (minimum-stress/maximum-stress), the data may not be directly applicable to the stress cycles being analyzed. As previously stated, this difficulty may be accounted for by constructing a modified Goodman diagram. This diagram is constructed by plotting the fatigue strength (alternating stress component for a given number of cycles) on the R ratio ray, from the given S-N curve, and projecting from these points to the ultimate strength (maximum mean stress with zero alternating component). By doing this for each value of cycles to failure (N), then constant life curves may be constructed as shown on figure 19. Figure 19 illustrates the fatigue life predictions for the old and new design of the 7- by 10-Ft blades. This figure shows the points on the diagram relating to operational and 2 per/rev. cycles. As can be seen on the diagram the redesign resulted in an improvement in predicted life of almost two orders of magnitude.

Figure 19. - Goodman Diagram for the 7- by 10-Foot Wind Tunnel Laminated Spruce Blades Illustrating Fatigue Life Predictions for Old and New Design.

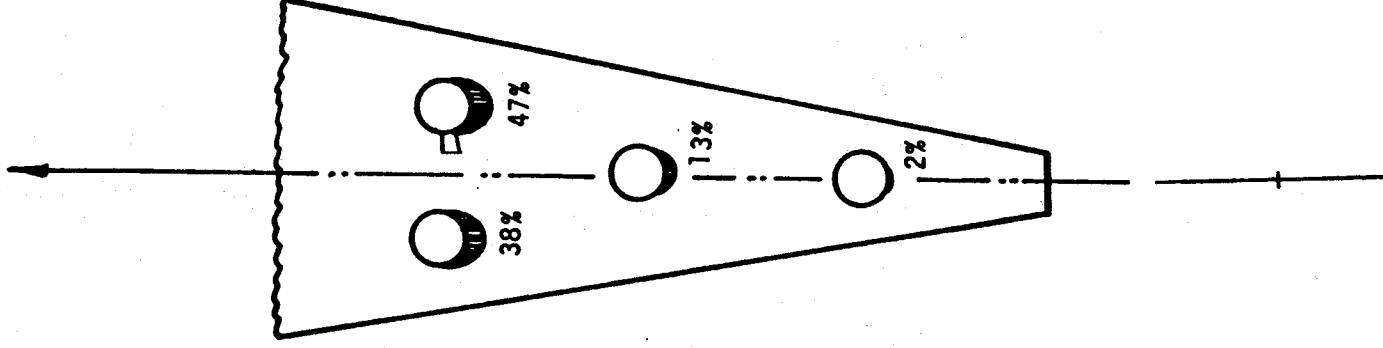
Concentration of the loads over a small area can result in high localized shear stresses in the blade to hub attachment region. The combination of attachment shear-out geometry, short transition, and high localized shear stress resulted in shearout of the LaRC 7- by 10-Ft Wind Tunnel blades. Historically (see Appendix A) this has been the major cause of wooden blade failures.

Figure 21. - Attachment pin loads (% of total load) for the NASA Langley Research Center 7-blade 10-Foot High Speed Wind Tunnel fan blades that failed.
